ANNUAL REPORT FOR 2014

Bald Creek Site #3 Mitigation Site

Yancey County

TIP No. R-2518B

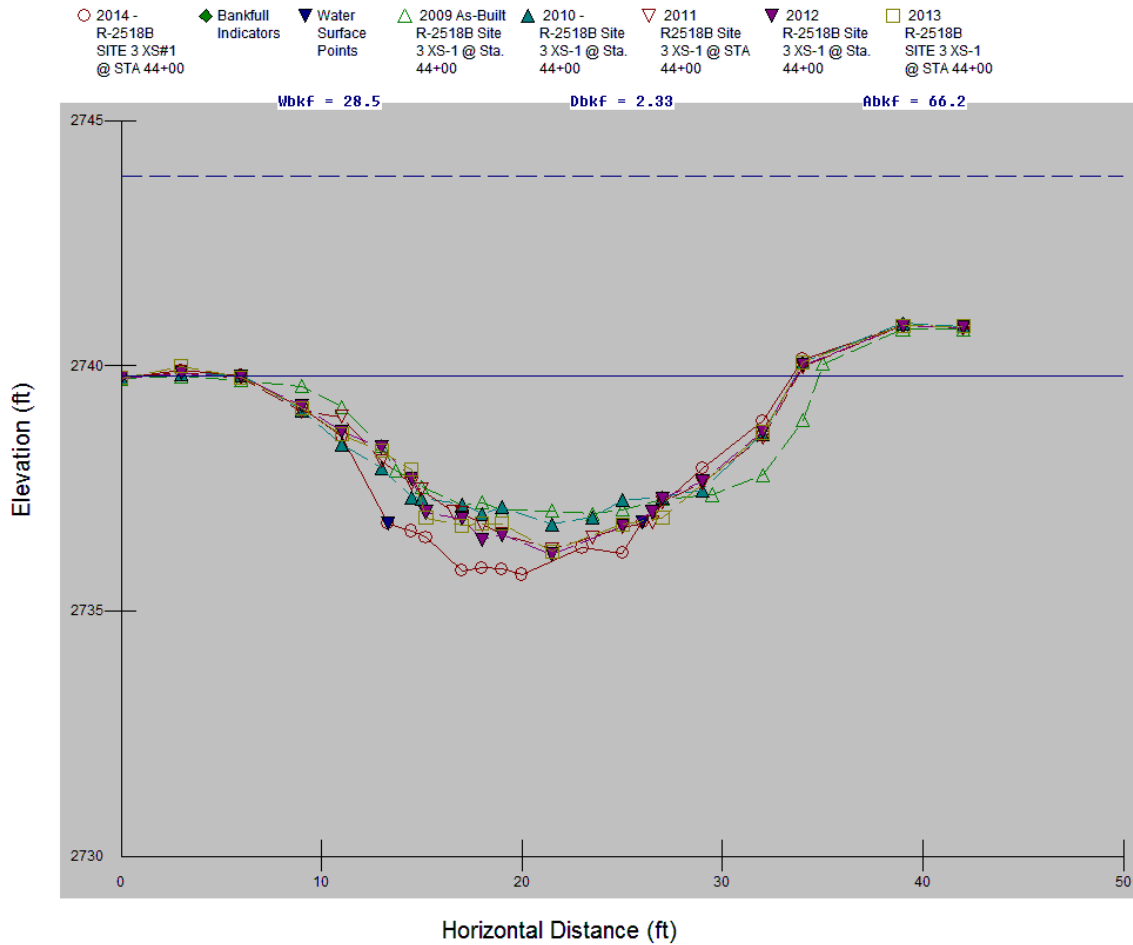
R-2518B SITE 3 XS#1 @ STA 44+00

Site #3: Cross-Section #1 (Riffle) Abbreviated Morphological Summary					
	2010	2011	2012	2013	2014
Bankfull Cross Sectional Area (ft ²)	55.19	56.45	57.19	57.15	66.24
Maximum Bankfull Depth (ft.)	3.05	3.49	3.62	3.55	4.06
Width of the Floodprone Area (ft.)	42	42	42	42	42
Bankfull Mean Depth (ft.)	1.85	2.04	2.02	2.06	2.33
Width/Depth Ratio	16.16	13.57	14.01	13.44	12.22
Entrenchment Ratio	1.4	1.52	1.48	1.52	1.47
Bankfull Width (ft.)	29.89	27.68	28.31	27.69	28.48

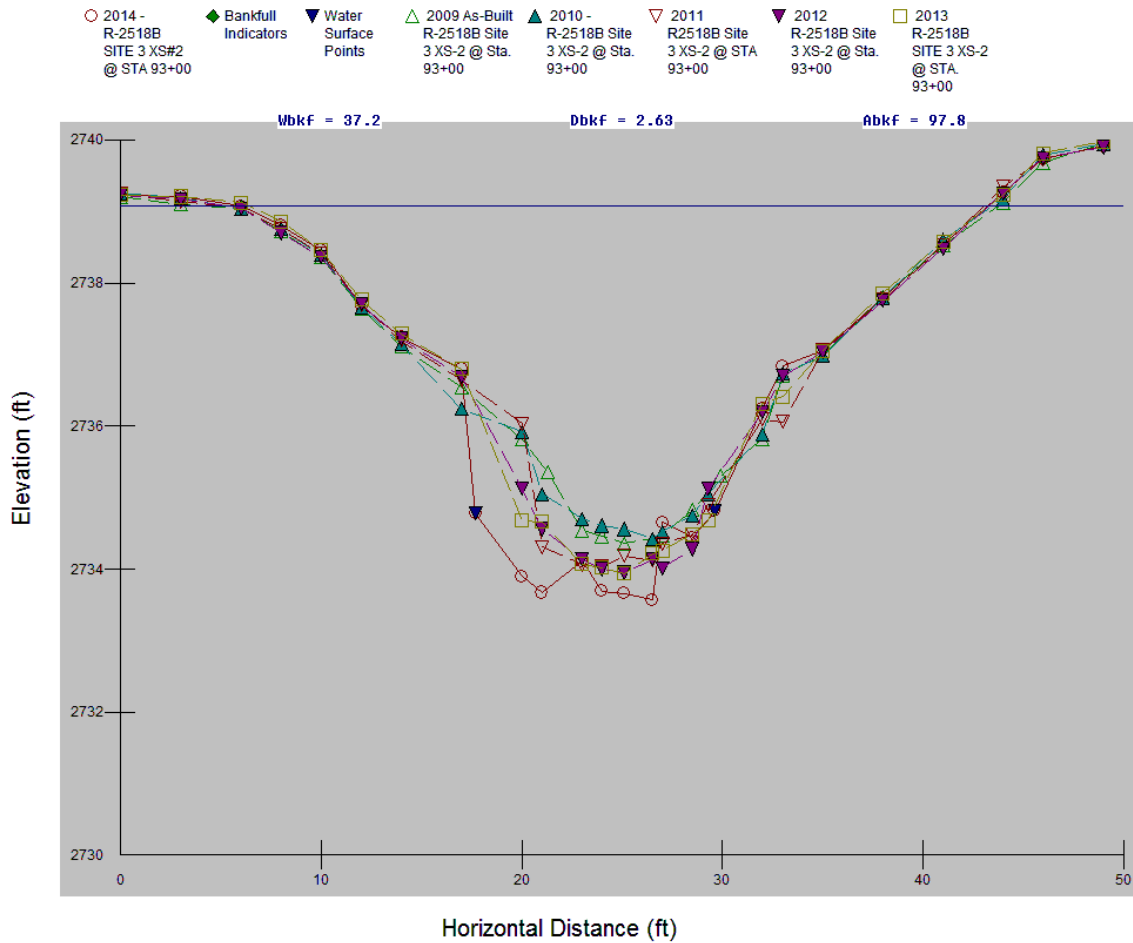
R-2518B SITE 3 XS#2 @ STA 93+00

and photo documentation at the permanent photo point locations would be completed. All other monitoring activities will continue to be completed throughout the five year monitoring period. Cross Section #2 graph shows that some localized erosion has occurred on the left bank at the end of the cross vane arm. Overall, the stream is stable. Pebble counts were not required per the permit conditions and therefore were not completed. Three bankfull events were documented by a surface water gauge at Site 3 during the 2014 monitoring year.

Site #3: Cross-Section #2 (Pool) Abbreviated Morphological Summary*					
	2010	2011	2012	2013	2014
Bankfull Cross Sectional Area (ft²)	86.6	90.04	91.01	93.36	97.78
Maximum Bankfull Depth (ft.)	4.61	5.0	5.09	5.18	5.5
Bankfull Mean Depth (ft.)	2.32	2.44	2.45	2.49	2.63
Bankfull Width (ft.)	37.26	36.9	37.18	37.49	37.22

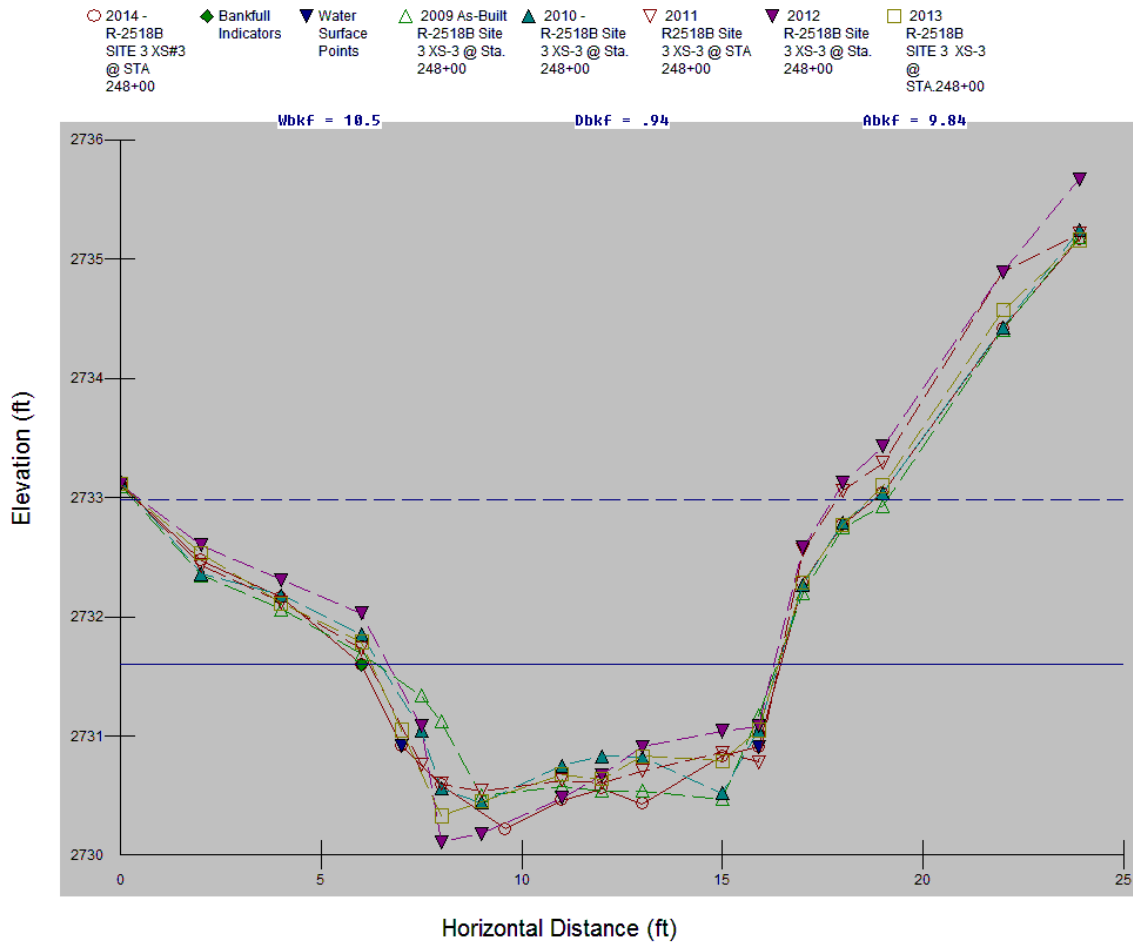
R-2518B SITE 3 XS#3 @ STA 248+00

Site #3: Cross-Section #3 (Riffle) Abbreviated Morphological Summary					
	2010	2011	2012	2013	2014
Bankfull Cross Sectional Area (ft ²)	10.67	9.87	12.72	10.49	9.84
Maximum Bankfull Depth (ft.)	1.41	1.19	1.92	1.46	1.38
Width of the Floodprone Area (ft.)	19.47	17.16	20.07	19.31	18.37
Bankfull Mean Depth (ft.)	1.01	0.94	1.2	0.99	0.94
Width/Depth Ratio	10.51	11.16	8.83	10.67	11.12
Entrenchment Ratio	1.83	1.64	1.89	1.83	1.76
Bankfull Width (ft.)	10.62	10.49	10.6	10.56	10.45

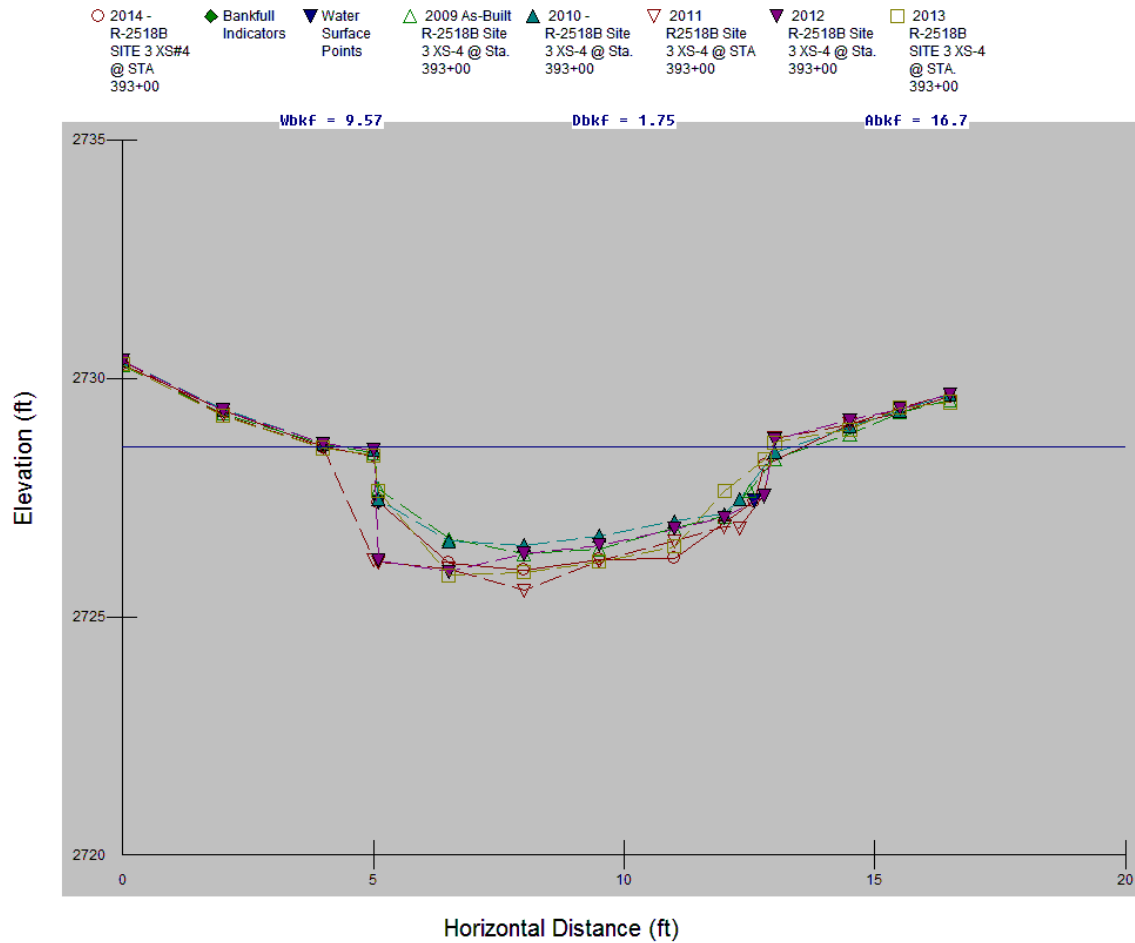
R-2518B SITE 3 XS#4 @ STA 393+00

Site #3: Cross-Section #4 (Pool) Abbreviated Morphological Summary*					
	2010	2011	2012	2013	2014
Bankfull Cross Sectional Area (ft ²)	12.56	19.4	16.63	15.65	16.72
Maximum Bankfull Depth (ft.)	2.0	3	2.69	2.67	2.58
Bankfull Mean Depth (ft.)	1.54	2.16	1.85	1.75	1.75
Bankfull Width (ft.)	8.14	8.97	8.98	8.93	9.57

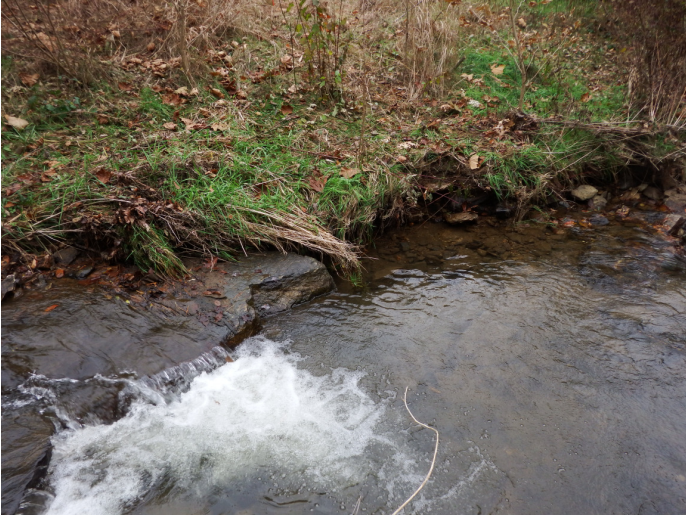
Left bank erosion at the end of the cross vane arm at Cross Section #2
November 2014

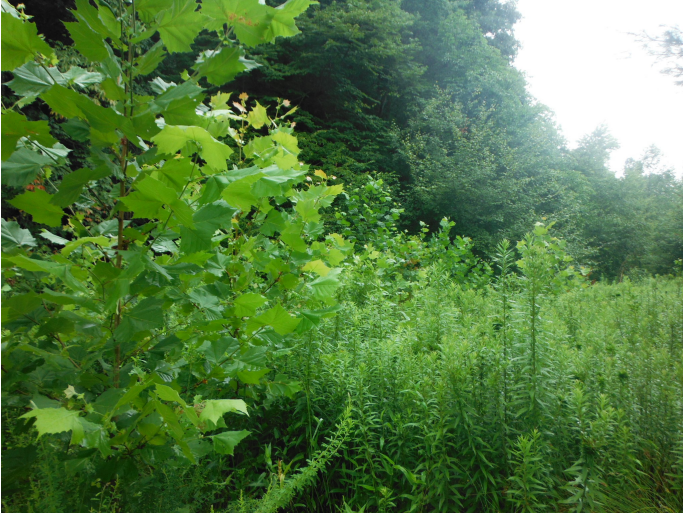
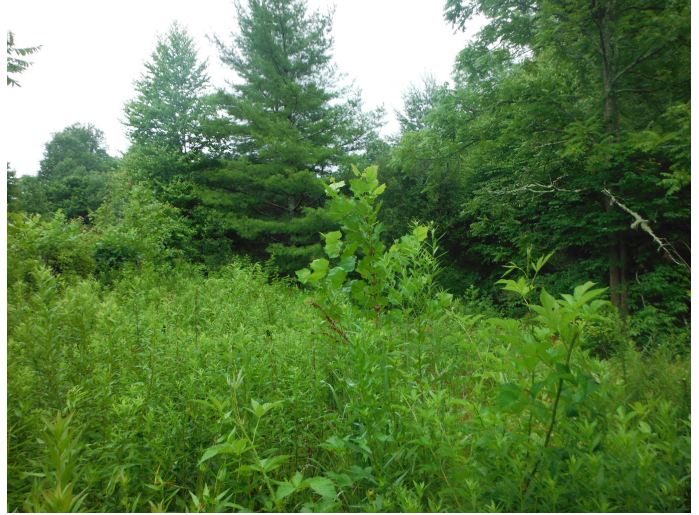
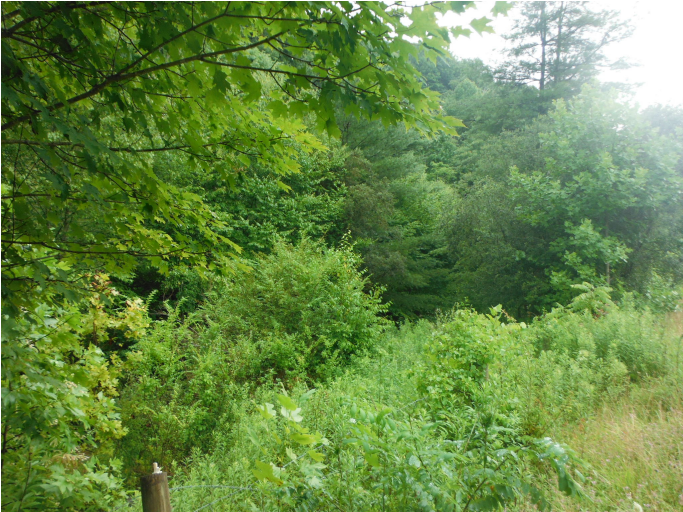
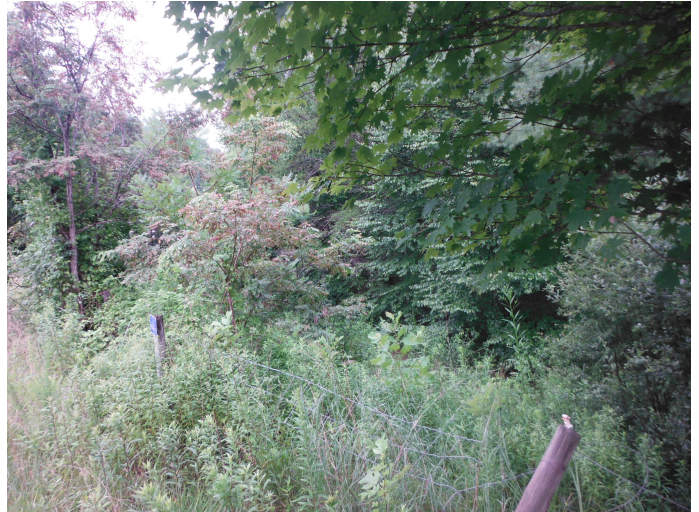
Streambank & Buffer Vegetation: The streambank reforestation was completed in March 2012. The Year 3 vegetation monitoring evaluation noted: Type I: Black Willow, Silky Dogwood and Type II: Sycamore, Green Ash, Tulip Poplar, and White Oak were surviving at the time of the monitoring evaluation.
